TECHNICAL EVALUATION
BOEING-VERTOL MODEL 347
ADVANCED TECHNOLOGY HELICOPTER

PHASE I

FINAL REPORT

US ARMY AVIATION SYSTEMS TEST ACTIVITY
EDWARDS AIR FORCE BASE, CALIFORNIA 93523

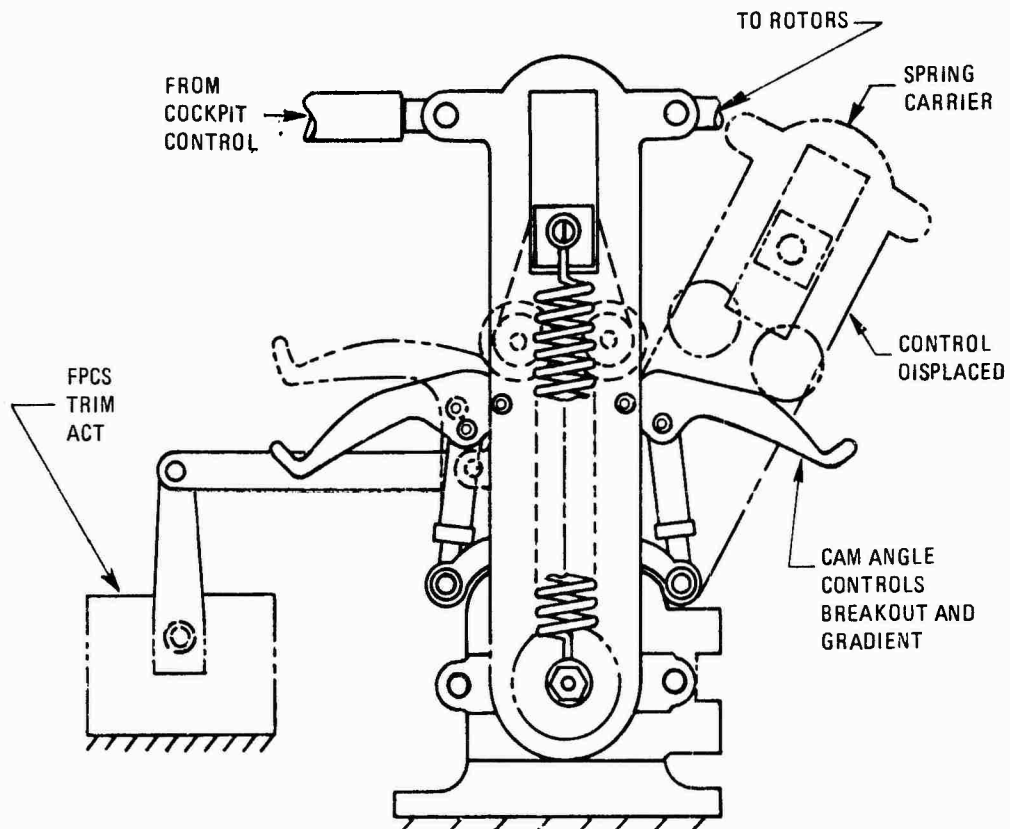
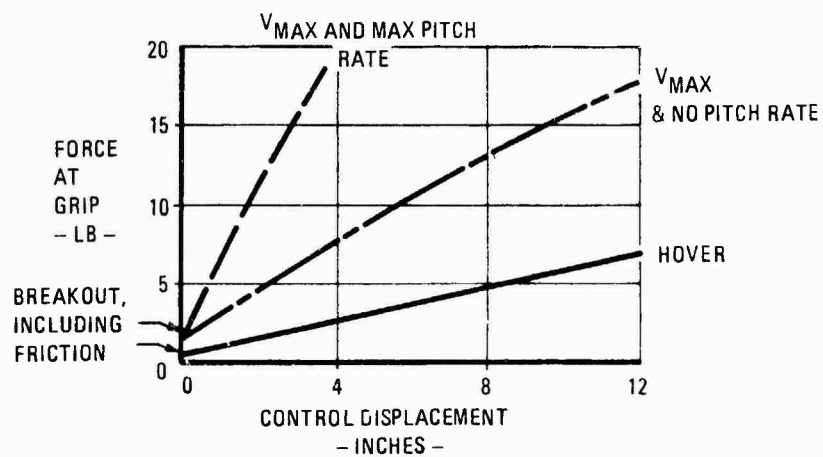
Figure 1. Variable Force-Feel System.

3. Variable force-feel systems provide longitudinal and lateral control pilot force cues which vary with airspeed. In addition, the longitudinal force-feel system also provides an increasing control force gradient with pitch rate. Directional control force feel is provided by a fixed spring capsule. The variable force-feel actuator used in the lateral and longitudinal systems is shown in figure 1. Also shown in figure 1 is an example plot of longitudinal control force characteristics under three different flight conditions. Lateral force characteristics are similar to those shown in figure 1 except that aircraft angular rates do not influence control forces.

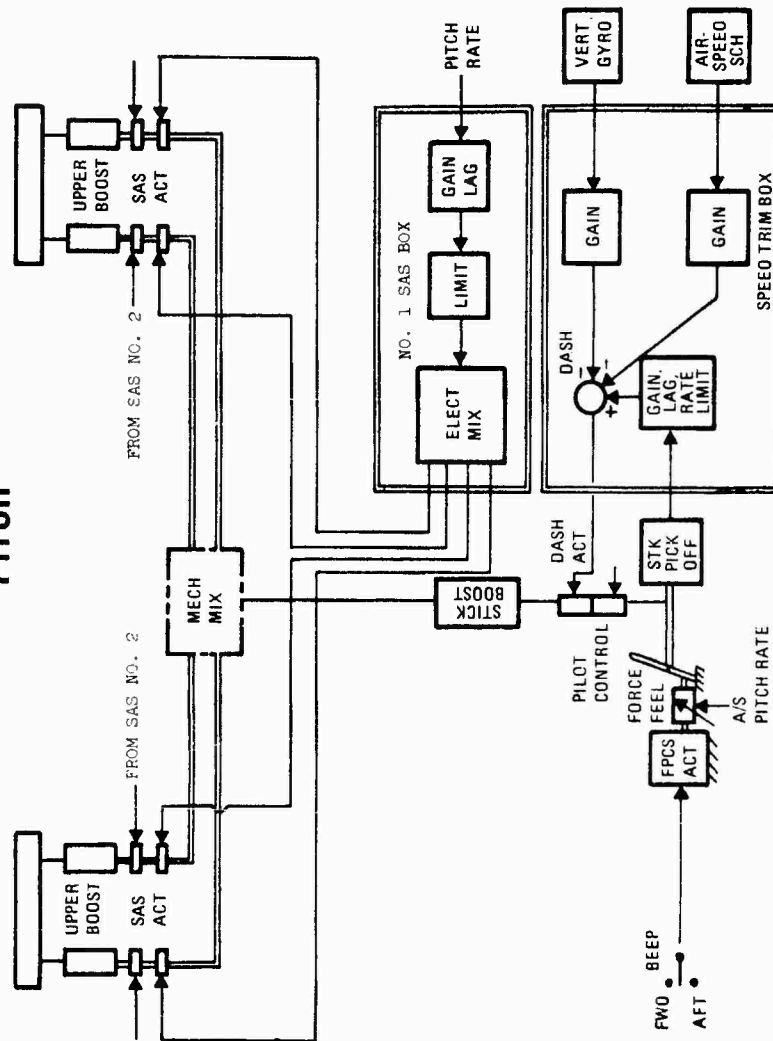
Figure 2. Model 347 Helicopter Flight Control System (Pitch).

5. As shown in figure 2, pitch rate damping is provided by a vertical rate gyro, the output of which is lagged, electrically limited, and applied through an electrical mixer to the upper SAS actuators. Unlike the CH-47C, which has individual, axis-oriented SAS actuators for pitch and roll located prior to the mechanical mixer, the SAS actuators which provide pitch and roll stabilization in the Model 347 are located beyond the mechanical mixer, and the same actuators provide both pitch and roll inputs to the rotors. An electrical mixer is therefore required in the Model 347 to convert the individual axis-oriented SAS signals to upper SAS actuator mixed commands. The SAS electrical mixer performs the same function as is performed by the mechanical mixer in converting single-axis mechanical control inputs into properly mixed upper boost actuator commands.

6. By summation of aircraft pitch attitude, airspeed, and longitudinal control position, the DASH system actuator provides pitch attitude and airspeed hold as well as a stable gradient of longitudinal control position versus trim airspeed. Since neither pitch attitude nor airspeed are synchronized, their high gain settings would, if not otherwise modified, require very large longitudinal control displacements to oppose their effects. The incorporation of a longitudinal control position transducer (stick pick-off) cancels out most of the airspeed and attitude signal so that the trim control travel over the allowable operating speed range is reduced to approximately 2-1/2 inches.

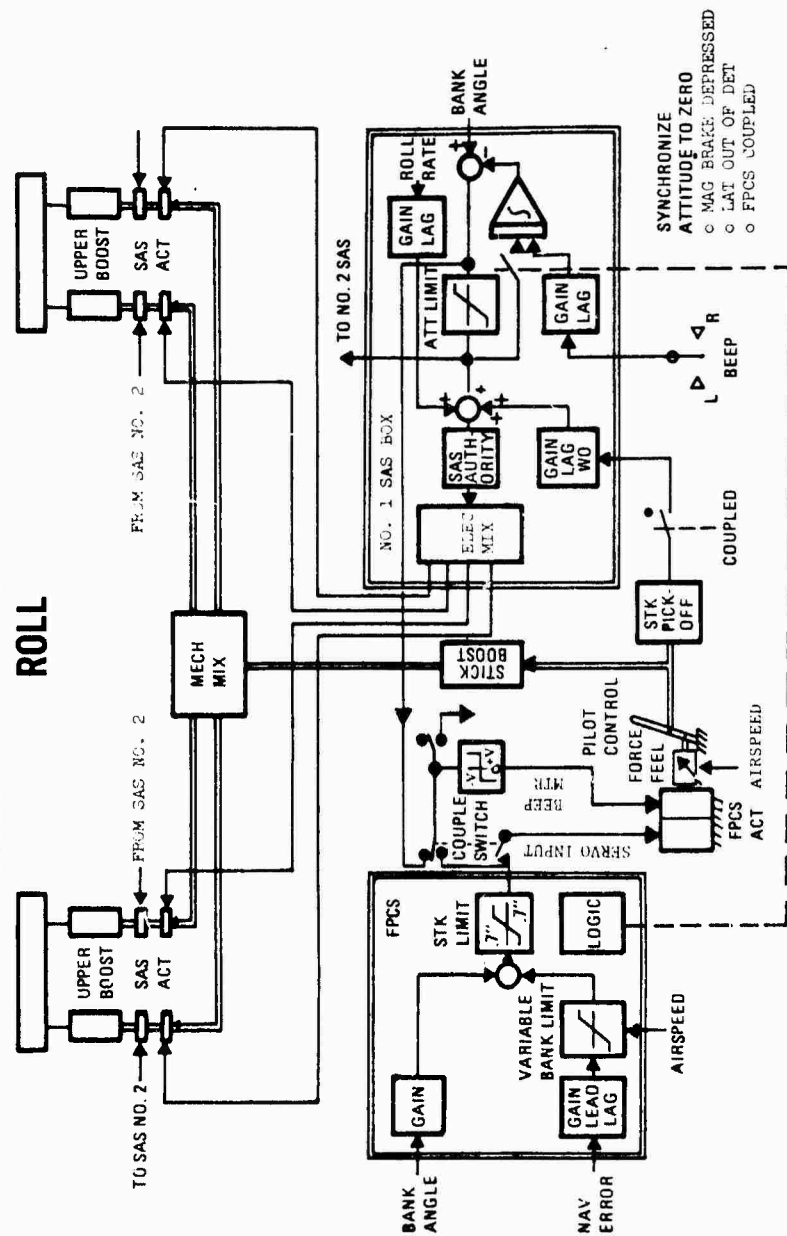
Figure 3. Model 347 Helicopter Flight Control System (Roll).

8. A block diagram of the lateral control system is shown in figure 3. Rate damping is provided by shaped inputs from a roll rate gyro to the upper SAS actuators. As in the case of longitudinal SAS inputs, necessary processing of the lateral SAS signals is performed by the electrical mixing unit. A control position transducer opposes the rate gyro signals so that the high stability of the roll SAS does not degrade lateral maneuverability. Summation of the rate gyro signal and the control position signal produces a roll-rate response which is proportional to control displacement. Long-term hold of trim bank attitude is provided by bank-angle inputs from a vertical gyro. Bank-angle error signals from the vertical gyro are used to produce corrective control motions through the upper SAS actuators and through the slow rate trim actuator, which repositions the pilot lateral control. When the pilot displaces the lateral control out of the detent position during maneuvering, the trim bank-angle error is continuously synchronized to zero. When the pilot returns the control to the detent position and the aircraft roll rate is less than 1 degree per second, the synchronizer switch opens and the system holds the aircraft at the bank angle stored at the integrator output. Vernier beep trim of bank attitude is produced by operation of the lateral beep trim switch. Operation of the lateral beep trim switch adjusts the trim bank angle stored at integrator.

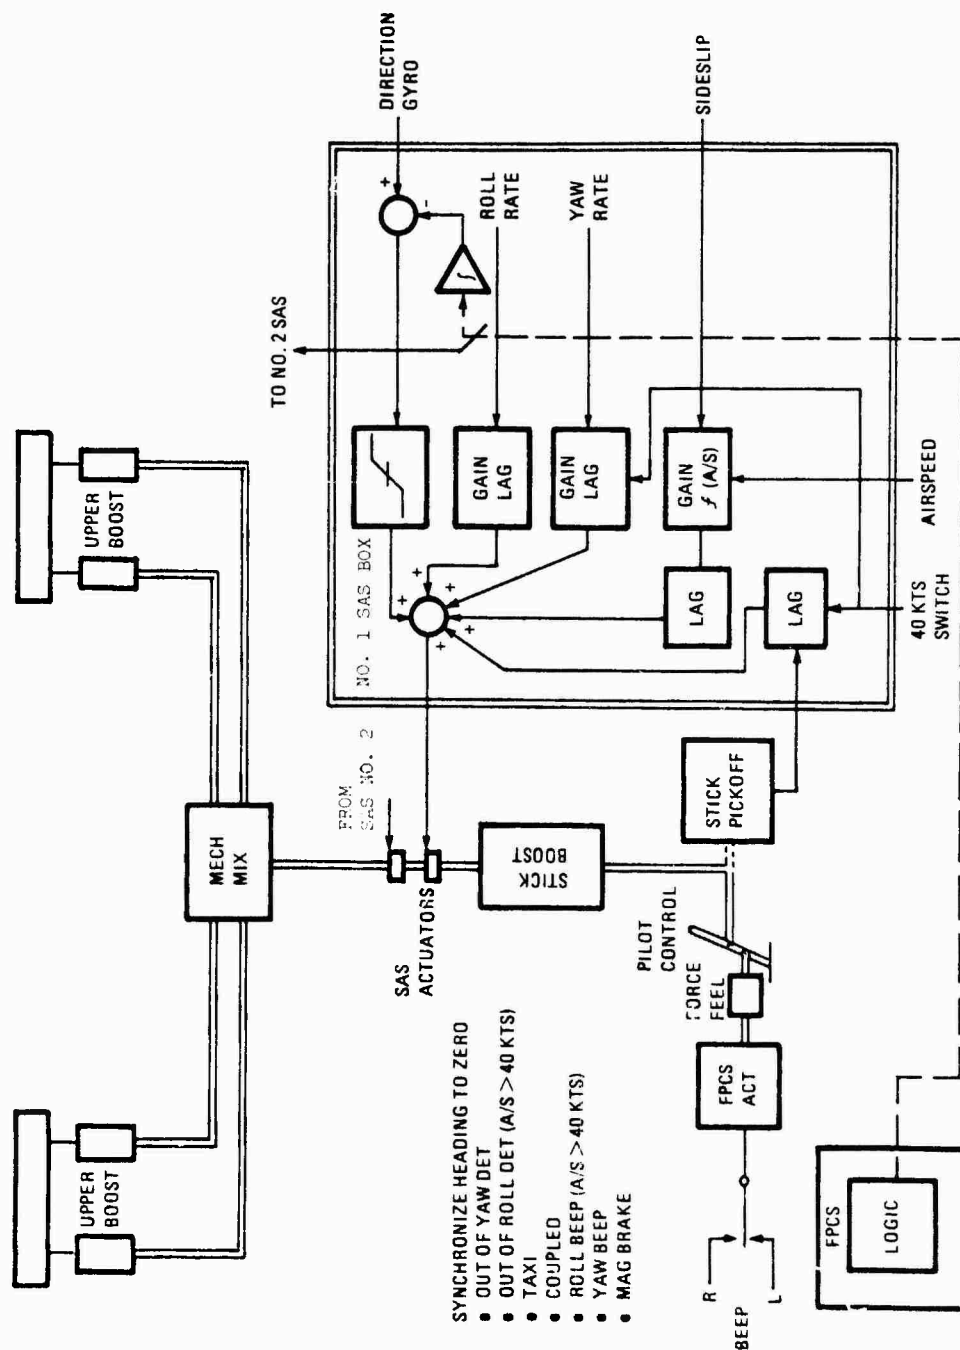
Figure 4. Model 347 Helicopter Flight Control System (Yaw).

10. As shown in figure 4, the directional control axis differs from the longitudinal and lateral axes, in that yaw SAS inputs are not processed by the electrical mixer. Since the yaw SAS actuator inputs occur before the mechanical mixer, yaw SAS inputs may be processed by the mechanical mixer. Rate damping and heading-hold functions are similar to those of the lateral axis. In addition, roll rate is coupled into the yaw SAS to provide automatic turn coordination.

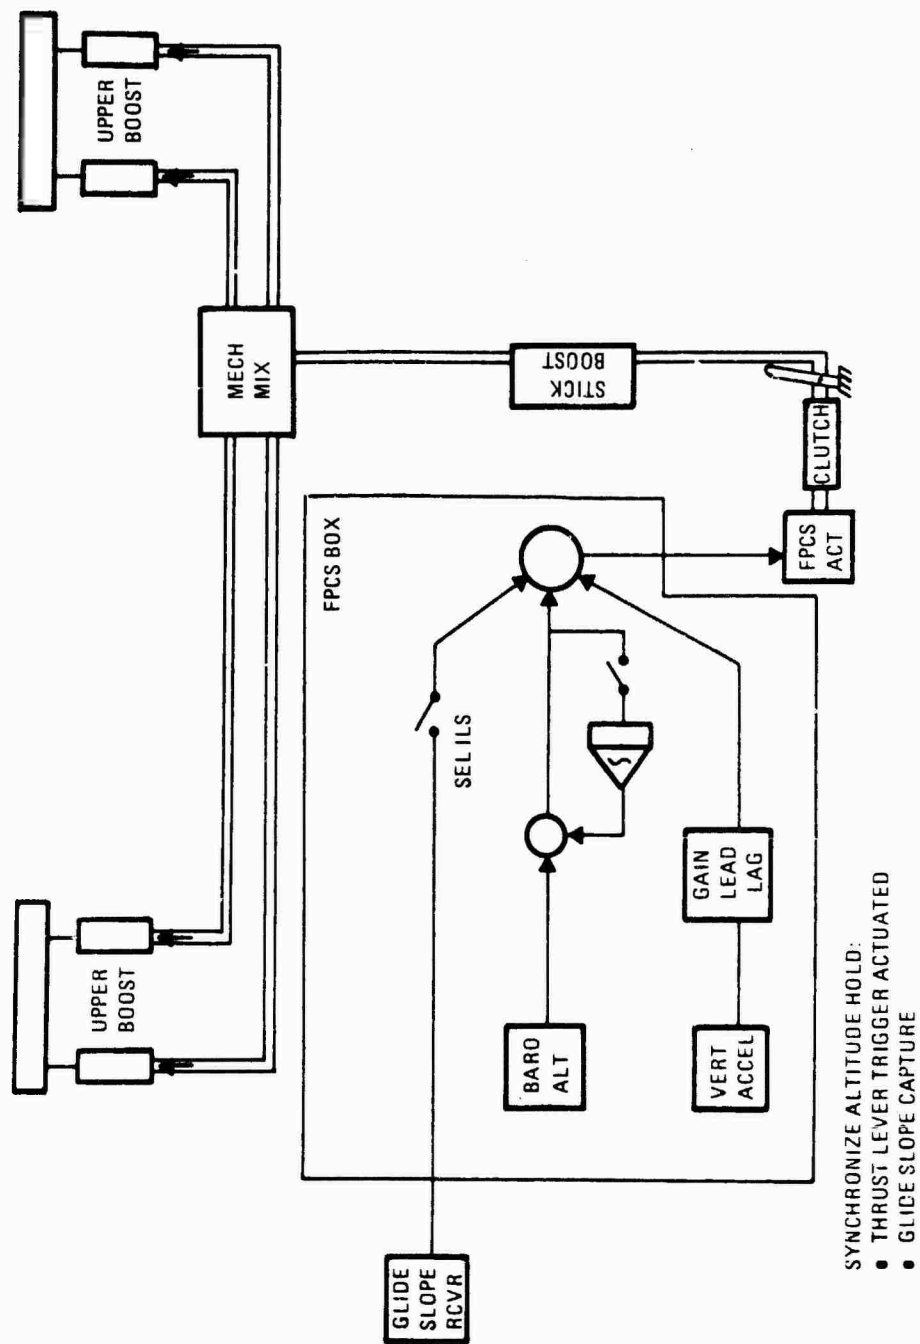
Figure 5. Model 347 Helicopter Flight Control System (Thrust).

12. A block diagram of the thrust axis control system is shown in figure 5. Automatic inputs into the thrust control system are produced only by the thrust FPCS actuator. These FPCS inputs are introduced only when one of the coupled operating modes is selected by the pilot. The altitude-hold function is accomplished from a barometric altimeter reference which operates through a synchronizer. At any time that the altitude hold is turned off or the thrust brake trigger is depressed, the barometric reference is continually synchronized to the existing pressure altitude. When the altitude hold is engaged and the thrust lever trigger is released, the pressure altitude stored at the output of the integrator at the time of engagement is maintained by the FPCS. A vertical accelerometer provides a vertical damping input to the FPCS.

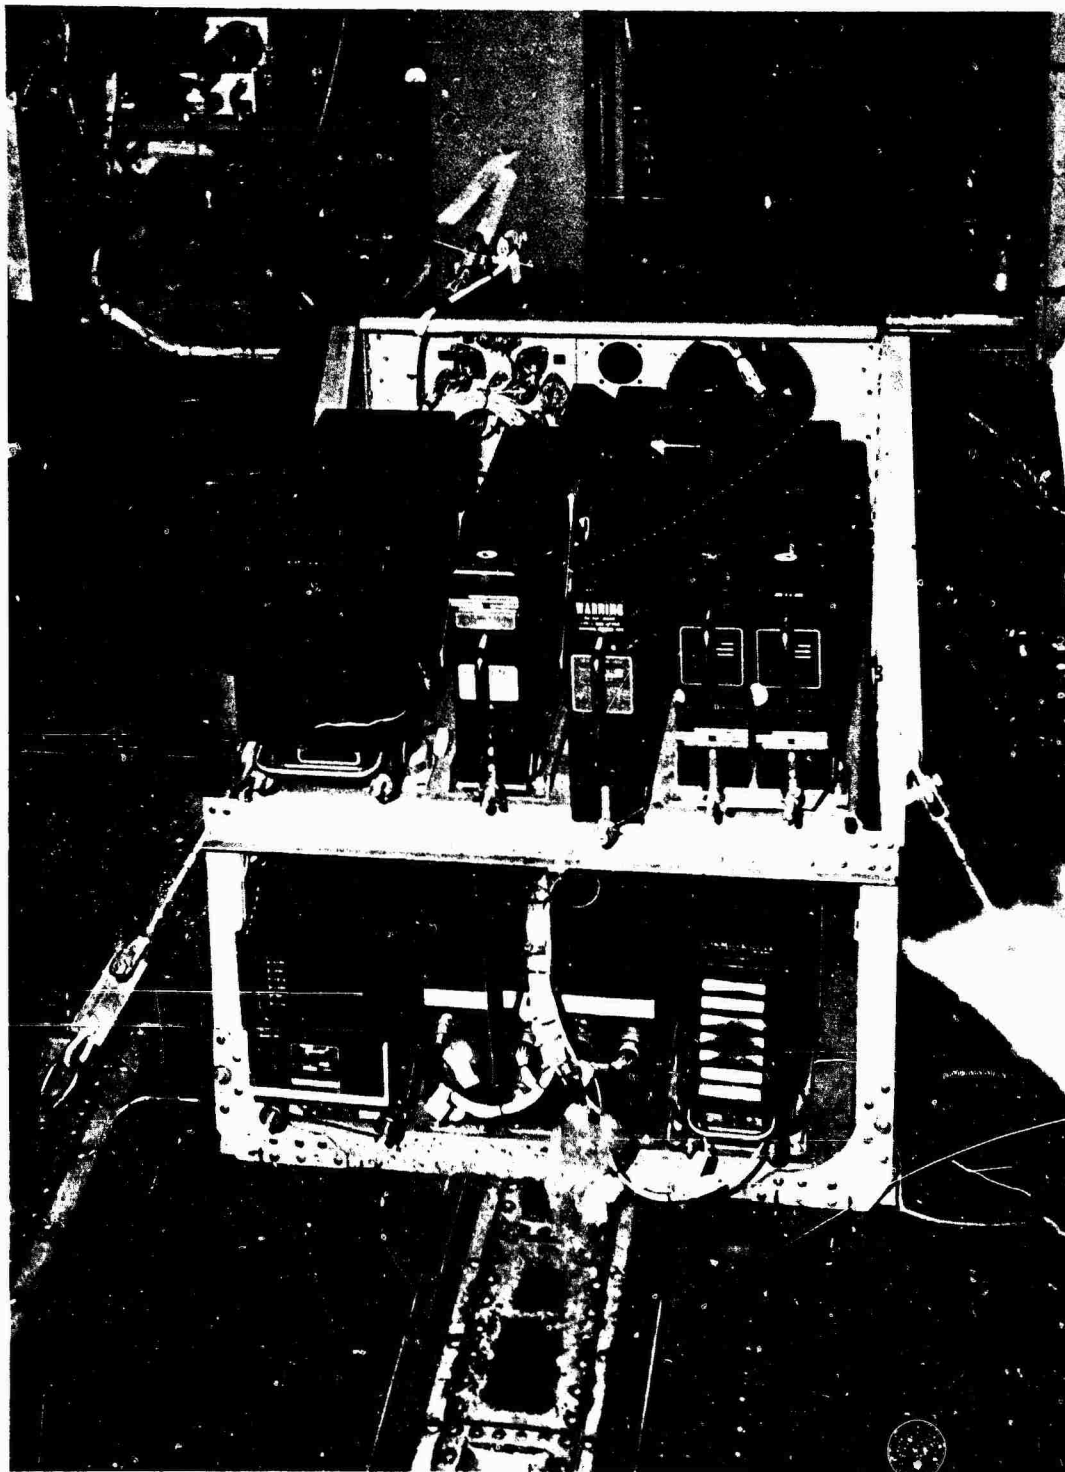
Photo 11. Test Instrumentation Mounted on Forward Cabin Floor.

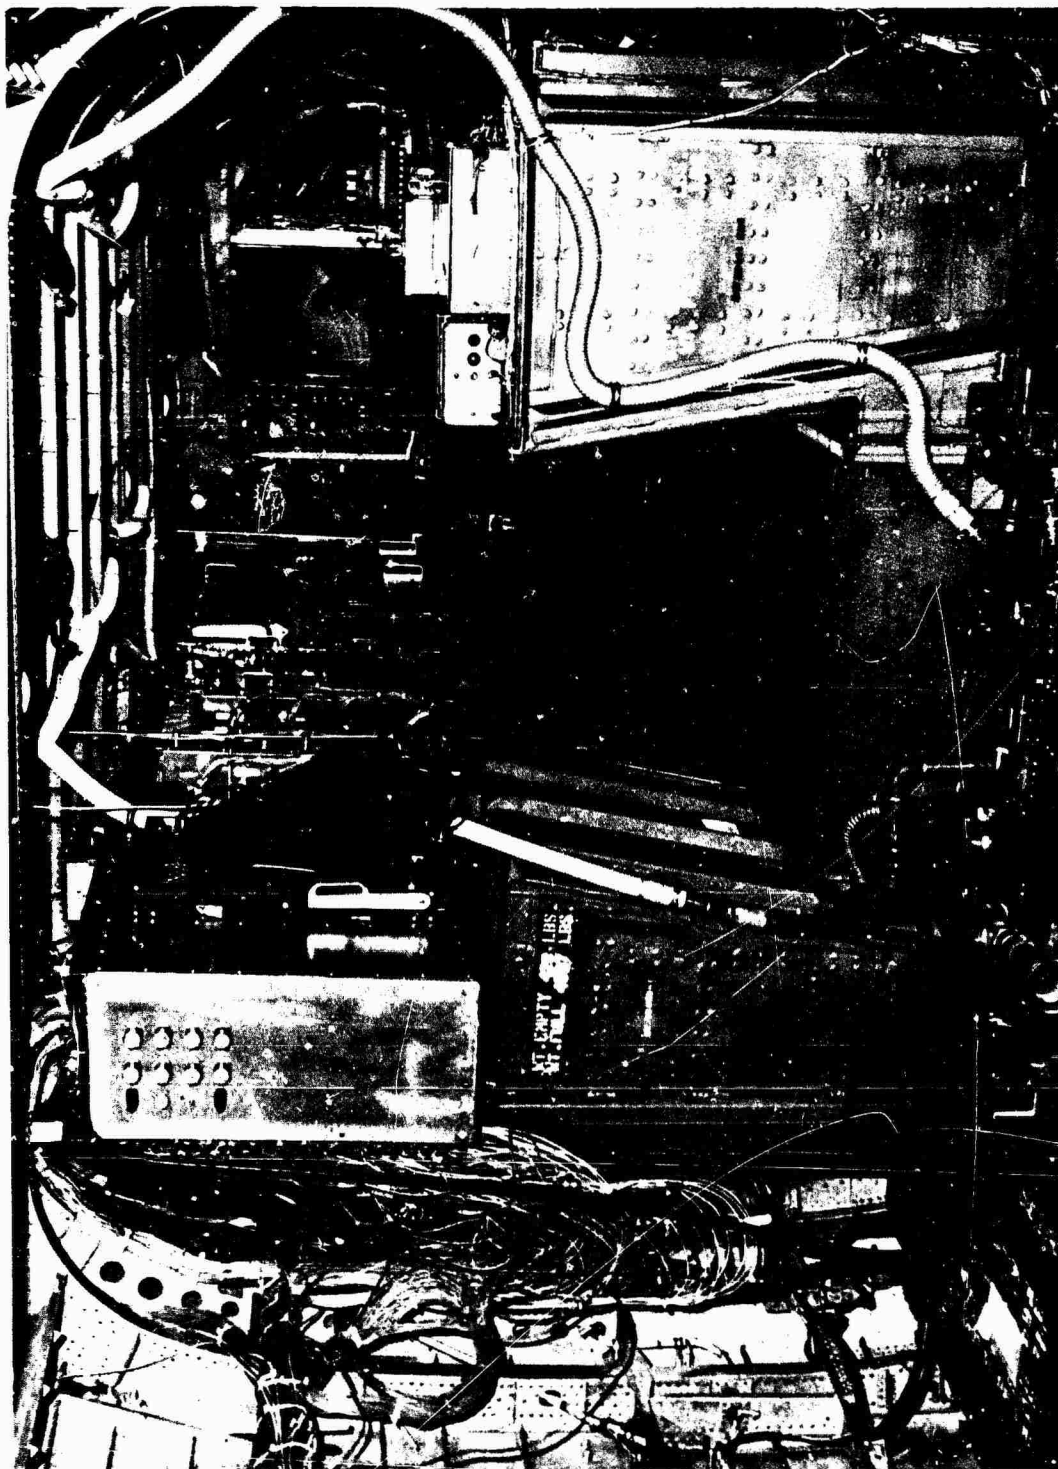
Photo 12. Water Ballast Tanks and Test Instrumentation Mounted at Mid-Cabin Area.
